# Manhole Inspection Summary

Manhole # S13EE1022MH

**Location** Address: **2703 OSWEGO AVE** Cross Street: **PARK HEIGHTS**

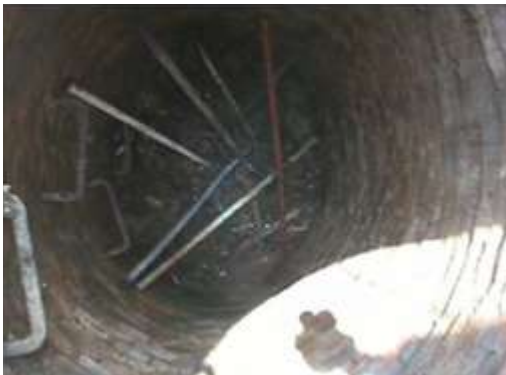
Top View

NOTE -DEBRIS

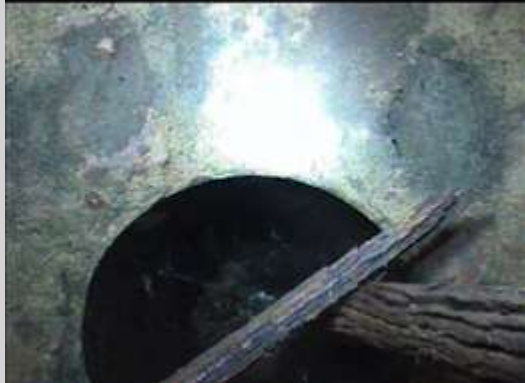
12 O'Clock Outflow

8 in. Circular Gravity Sewer  
Pipe Out @ 12 O'Clock

Deposits: ☐ None ☐ Mud ☐ Sludge ☒ **Debris** ☐ Grease

Silt Depth: **1.5** (in.) Deposits Extent: **Medium**
